**Comprehensive Lake Study  
of  
Clear Lake  
in  
Waseca, Minnesota**

BMI Project No. M13.33471

November 2003

**BOLTON & MENK, INC.**  
Consulting Engineers & Surveyors

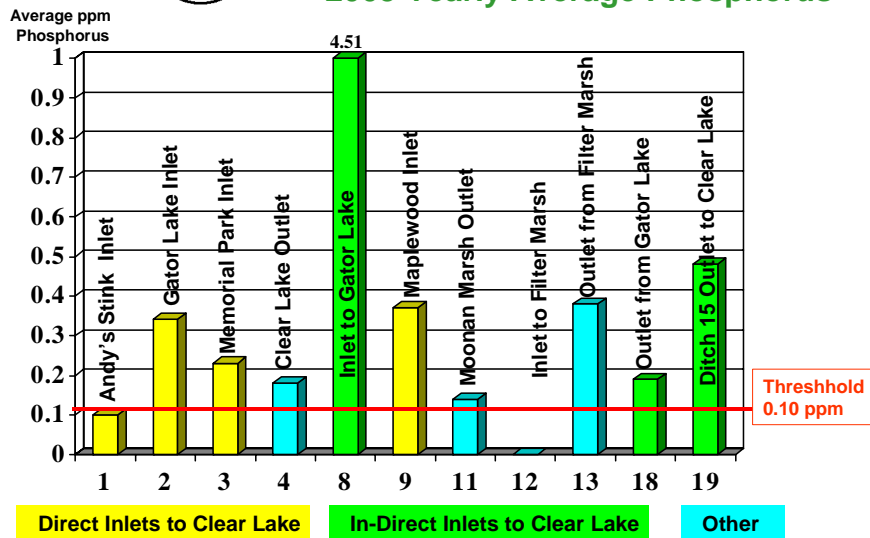
### 2003 Yearly Average Phosphorus

As can be seen in the graph, the inlet of 4.51 ppm was treated to a level of less than 0.2 ppm by Gaiter. Once that outfall joined the untreated County Ditch 15-1 water, the concentration that reached Clear Lake was approximately 0.48 ppm.

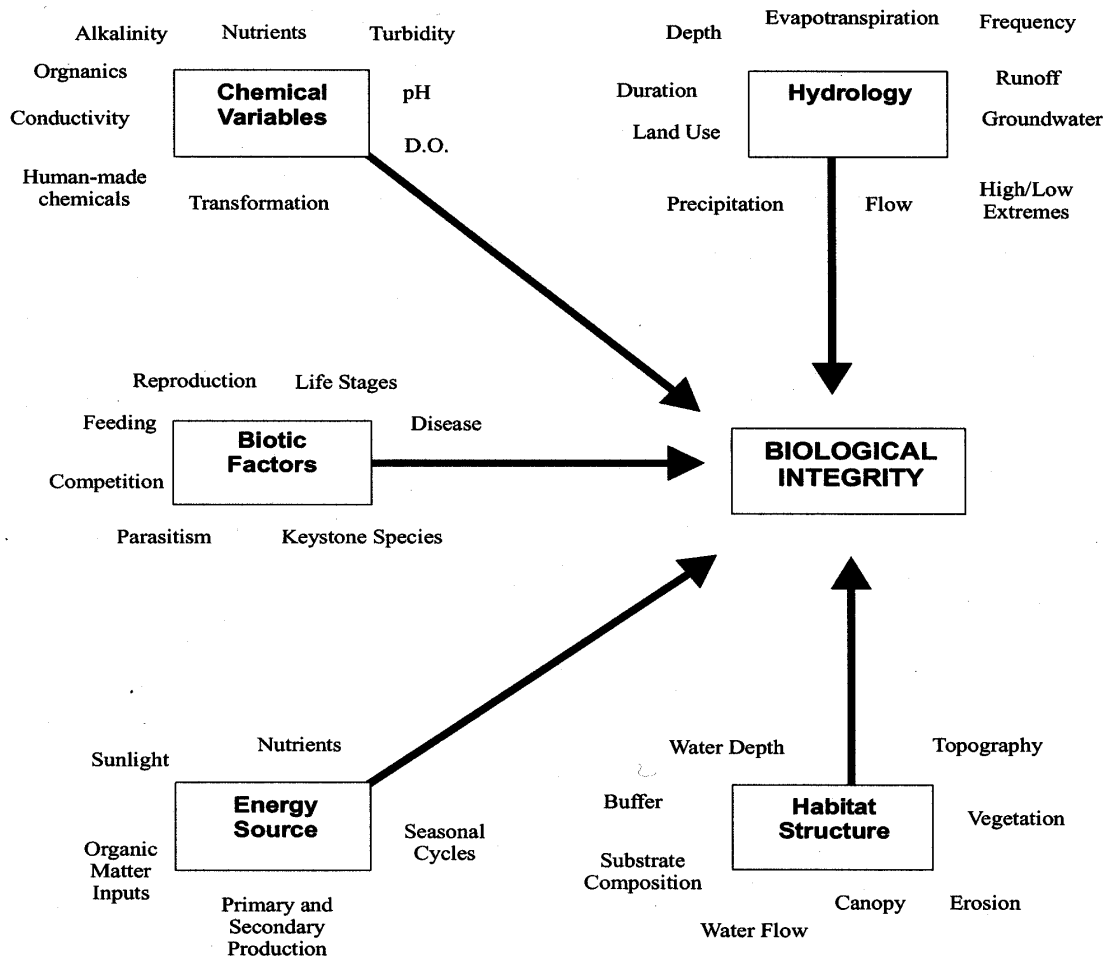
Ecosystem Influences on Biological Integrity (Adapted from Karr, et. al. 1986, Yoder 1995<sup>14</sup>)
